WETLAND RESTORATION TO ENHANCE BIODIVERSITY IN URBAN AREAS : A COMPARATIVE ANALYSIS

Kwi-Gon Kim, Hoon Lee, Dong-Hyun Lee

* This paper has been presented at the URBIO 2010, Nagoya, Japan, as the paper for keynote speech.

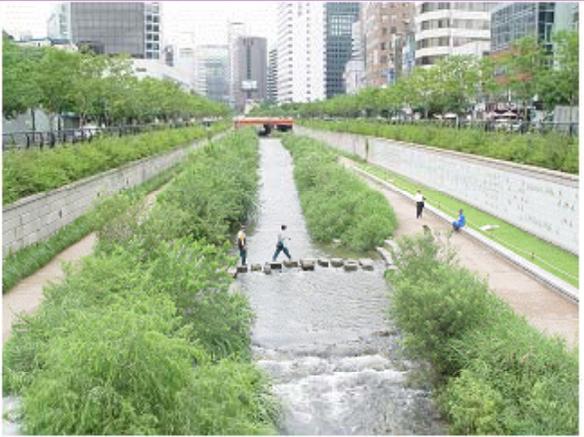
<ul style="list-style-type: none"> ▪ Lakefront Restoration is achieved by using vegetation
<p>Jangtong Bridge~Gwansoo Bridge</p>

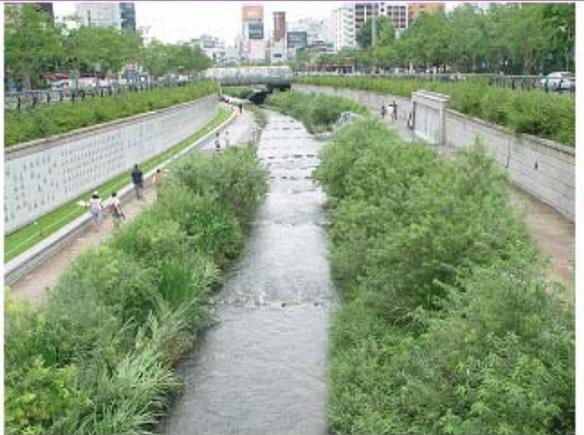
<ul style="list-style-type: none"> ▪ Lakefront Restoration is achieved while giving change to water flow using stones

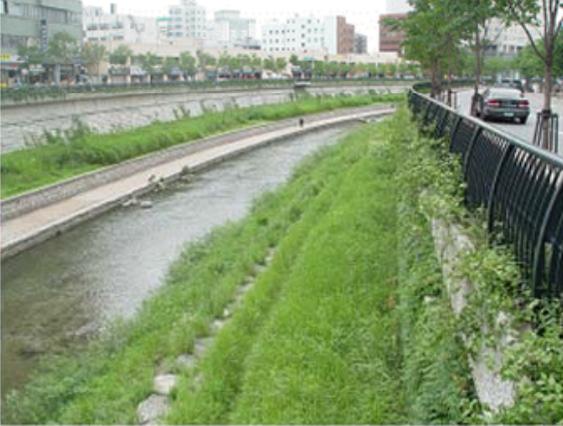
<ul style="list-style-type: none"> •Putting more emphasis on ecological aspects by developing only one side for pedestrians' sidewalk
In the neighborhood of the Biwoodang Bridge

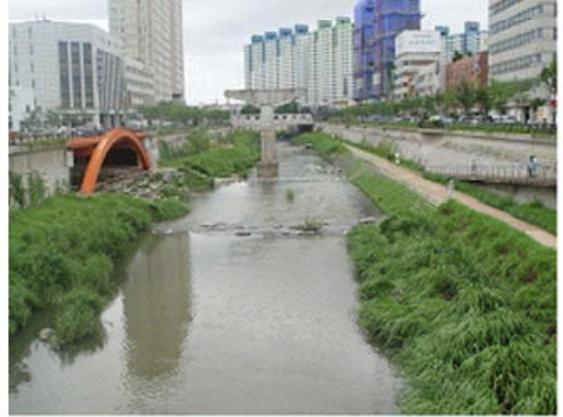
<ul style="list-style-type: none"> •By developing only one side for pedestrians' pathway with the width of a stream wider, ecological aspects of a stream is highlighted.
The Jungryang Stream confluence section for preservation area for migratory birds

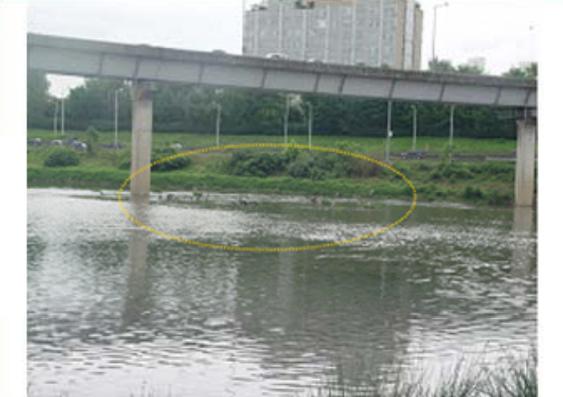
<ul style="list-style-type: none"> •It was restored with its ecological aspects emphasized almost without human use of it.

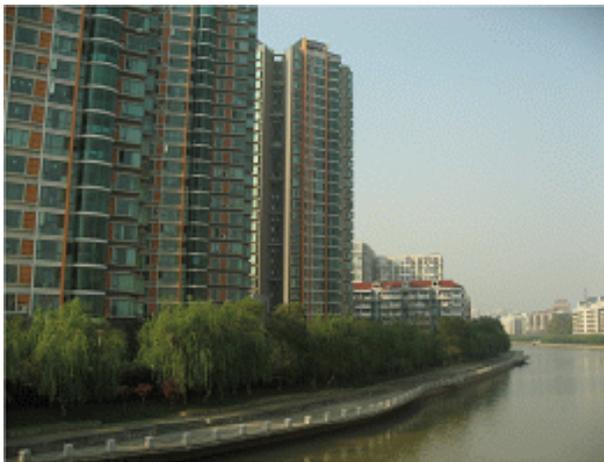
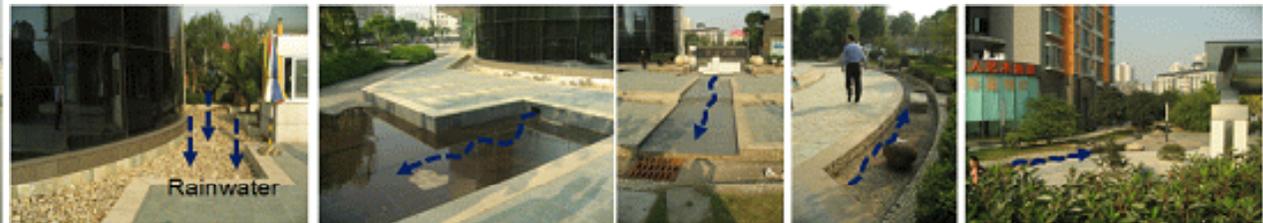
Waterfront and Recycling Housing and Appearance of rainwater circulation system establishment in the complex adjacent to the waterfront

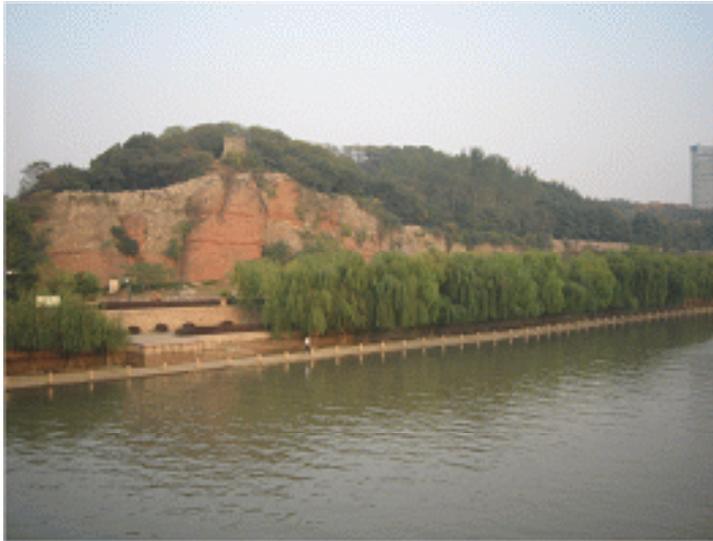
It shows the appearance of soil exposed to the riverfront where afforestation of its slope side is needed.

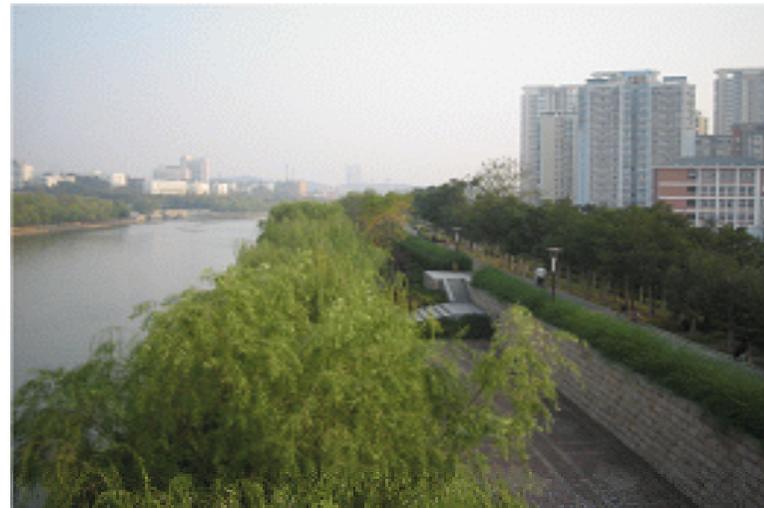
By defining a river, humans, and using space through the planting of luxuriant forest trees, river eco-system is being preserved

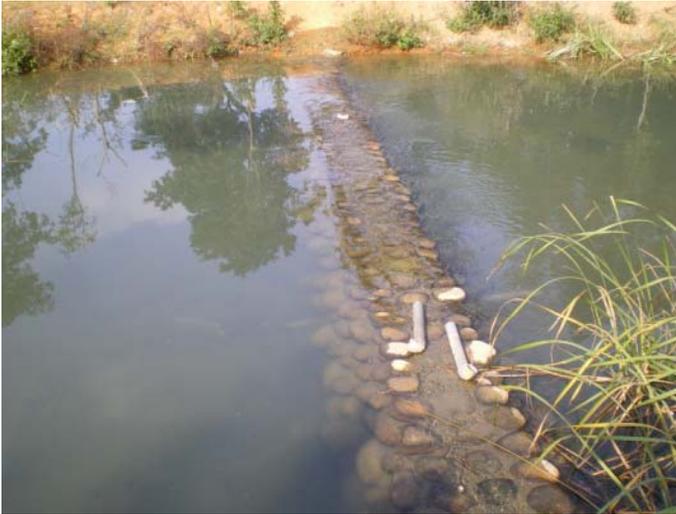
Stream flow can be controlled by putting the block at the center of the water passageway

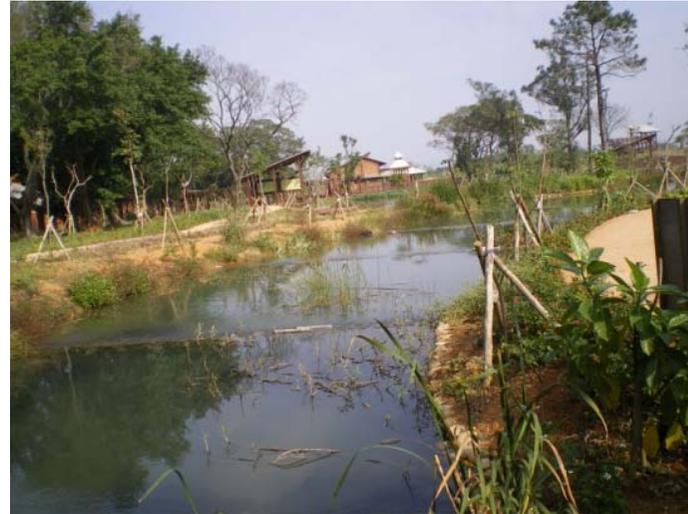
Habitat for the multiple plants by acquiring the open water surface

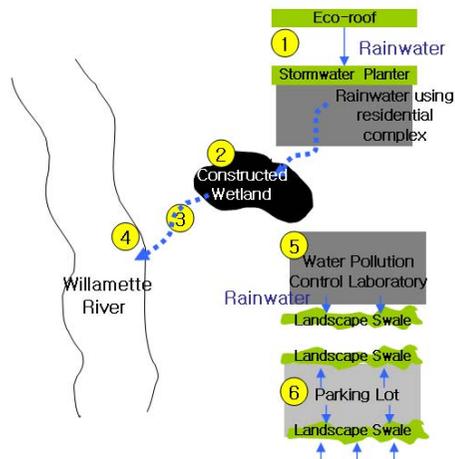
Stormwater Chain by Water Pollution Control Laboratory in Portland, Oregon

- A stormwater chain was built by using rainwater in parking lots and roofs
- In particular, stormwater from residential complexes was purified in a constructed wetland

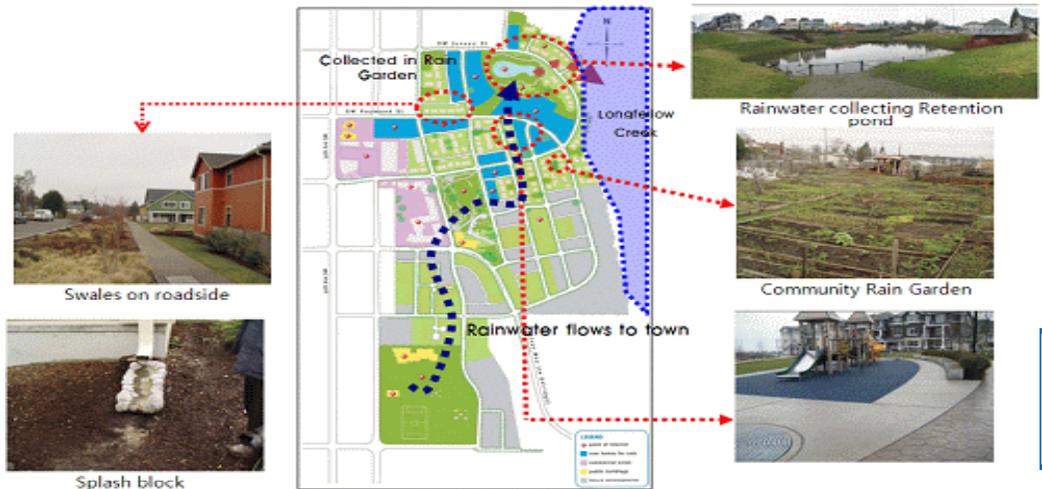
Sites of Stormwater Chain in High Point Neighborhood in Seattle, Washington

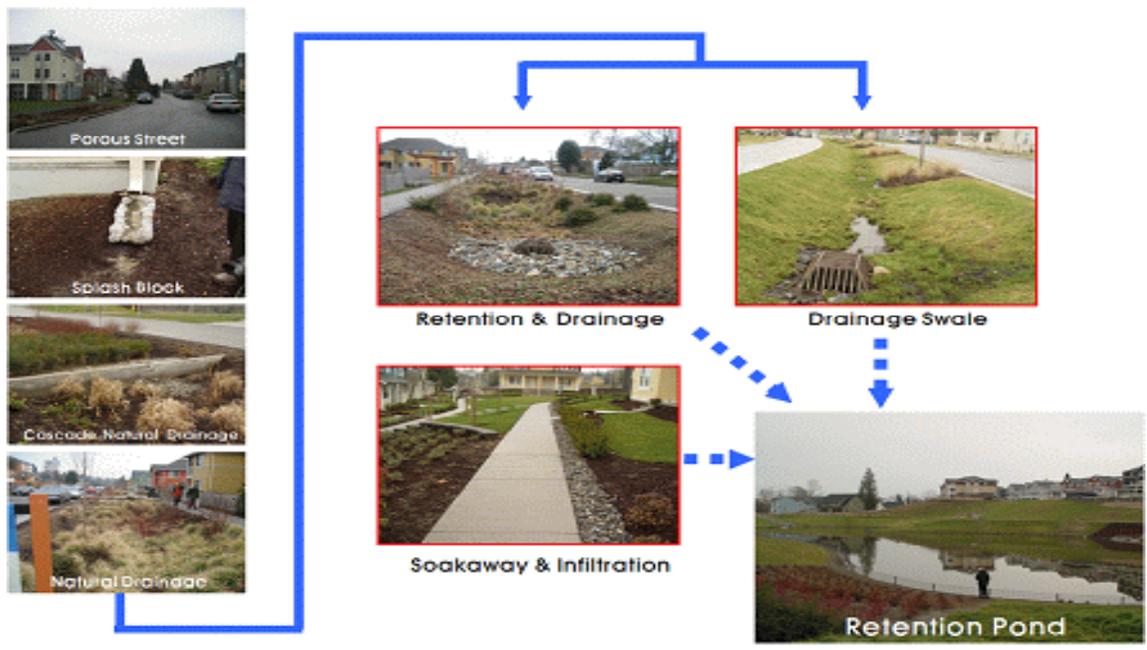
Mimetic Diagram of Stormwater Chain in High Point Neighborhood in Seattle, Washington

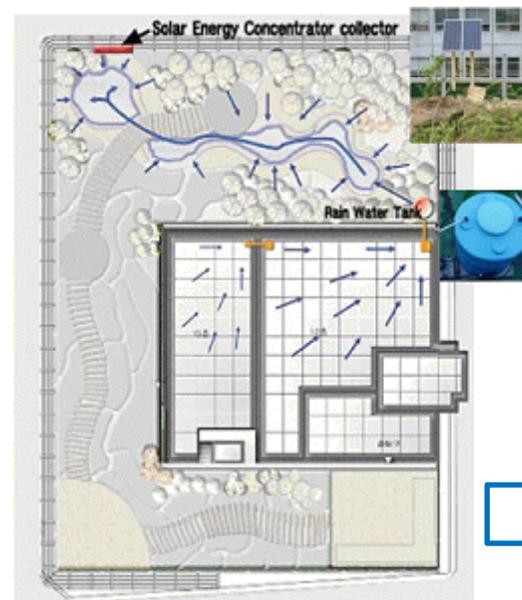
Wetland Plan Using Rainwater

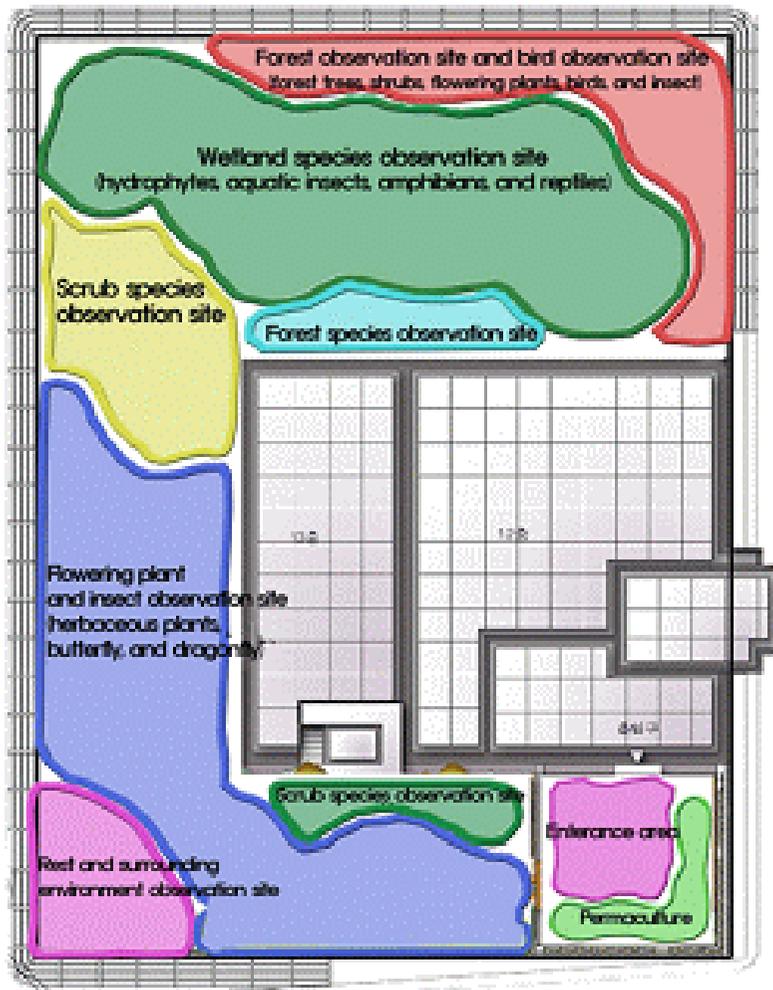
Basic Concept Map

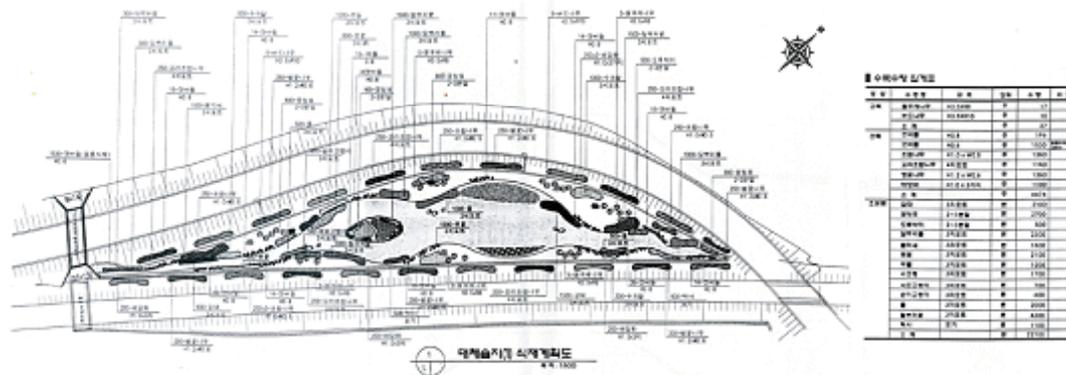
Basic drawing of Donghae Line replacement wetland

- The compensation for the damaged and influenced wetlands is necessary and the ratio of compensation has to be bigger than the buried wetland for the proper structuring and functioning as wetlands.
- The replacement wetland is selected and planned reflecting on such characteristics
- To make the smooth circulation of thrust, nutritional material and sediments in the area
- As the target area of Donghae replacement wetland is the proximity of river flowing into the sea, it has to be fostered to make this river to be connected as continuous stream.
- Fostering the habitat of amphibians within replacement wetland
- Fostering the shelters and breeding place focused at the living birds at wetland

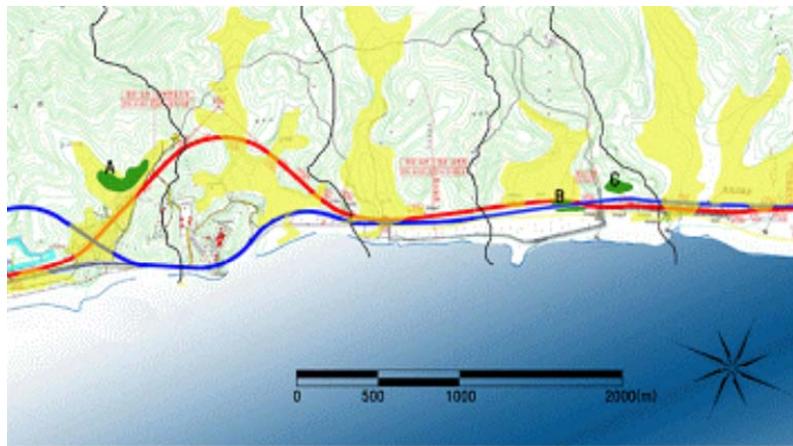
Locations of the influenced wetland and replacement wetland

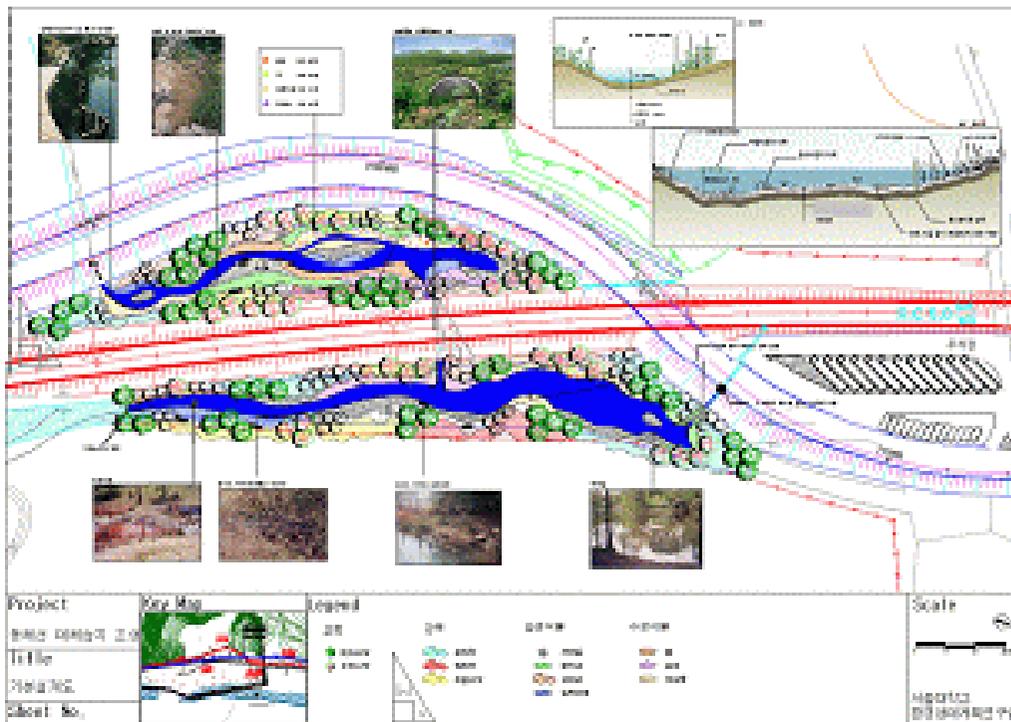
Basic diagram of Donghae Line replacement wetland
